HIFI TEI TEST REPORT

Doc. no. : SRON-U/HIFI/RP/2001-023

Title **HIFI TEI test report**

This document reports the test of the TEI software as carried out according to AD 3.

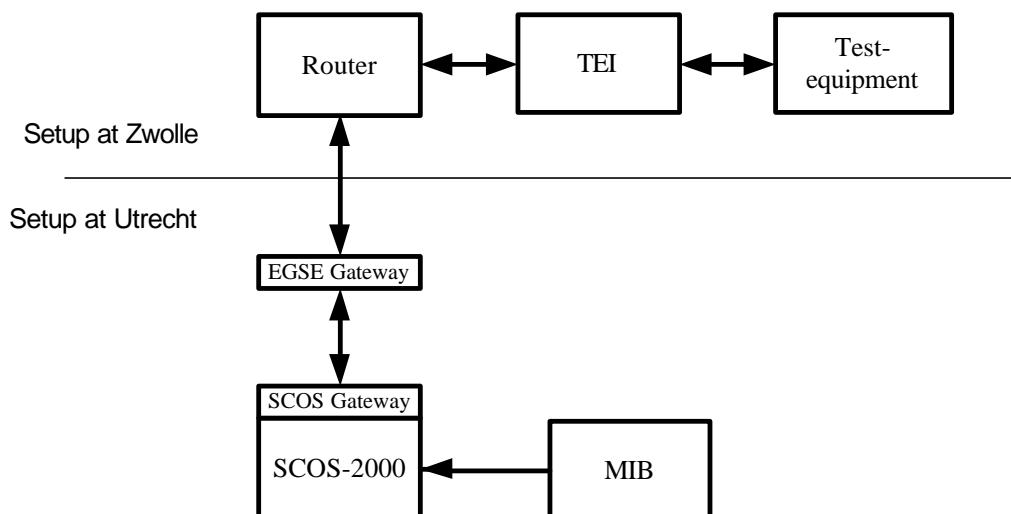
TEI and SCOS

The figure shows the components and where they are running. On the PC in Zwolle the Manual Stack and the Desk-top could be displayed. There were difficulties with displaying the Alphanumeric displays.

A command could be issued by the Manual stack to the TEI. The command was accepted properly by the TEI.

The House-keeping packets were generated by TEI and received by SCOS-2000. When an OOL-value of the compressor status is generated, SCOS-2000 Desk-top displays the error-message KM066 out of range. This demonstrates that the TM-packets are received properly by SCOS-2000 and interpreted properly.
