Pacs FM (ILT, IST, TVTB, CoP) Short Performance Test: 518 Test of internal calibration recipes in photometry

T. G. Müller

July 7, 2009

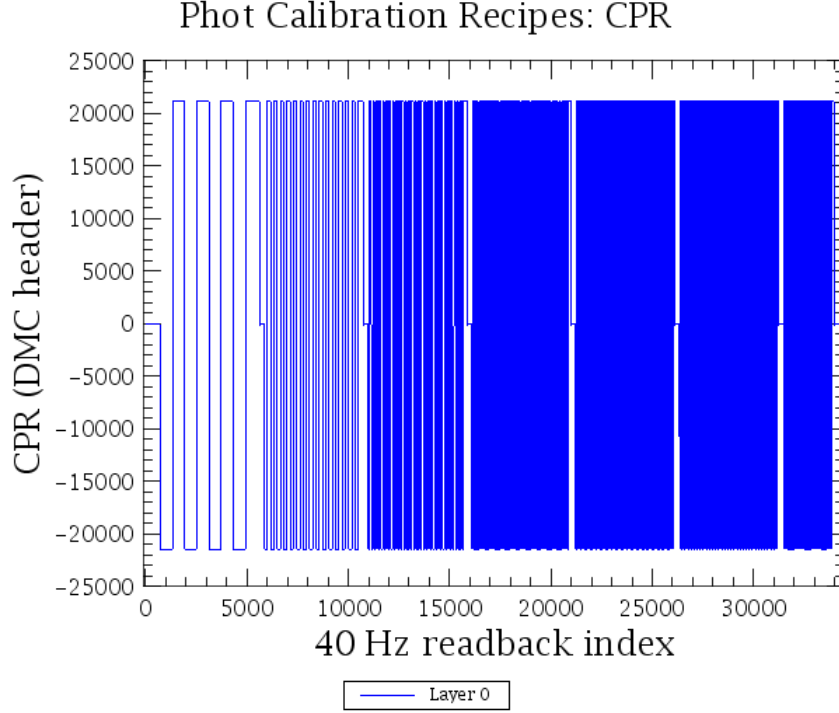
Figure 1: The chopper pattern during the first part of the test in filter A.

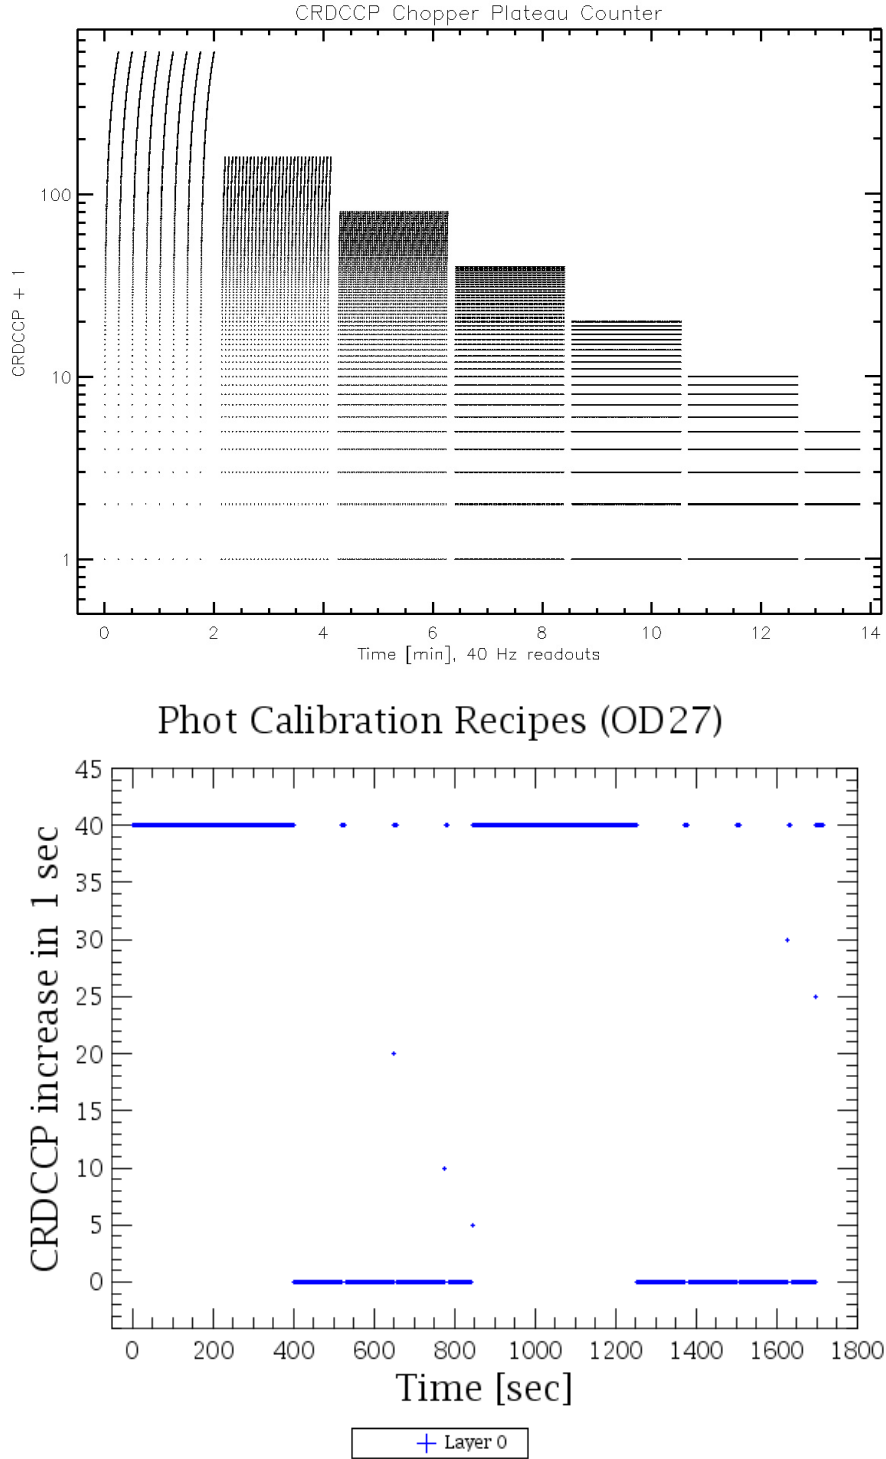
Figure 2: Top: The CRDCCP chopper plateau counter for the first and the second 7 DMC sequences. The counter increases for each chopper plateau to the exact commanded number of readouts (600, 160, 80, 40, 20, 10, 5 readouts). Bottom: The CRDCCP increase during the OBCP executions. The counter is correctly increasing with 40 units per second (NCR 4497).

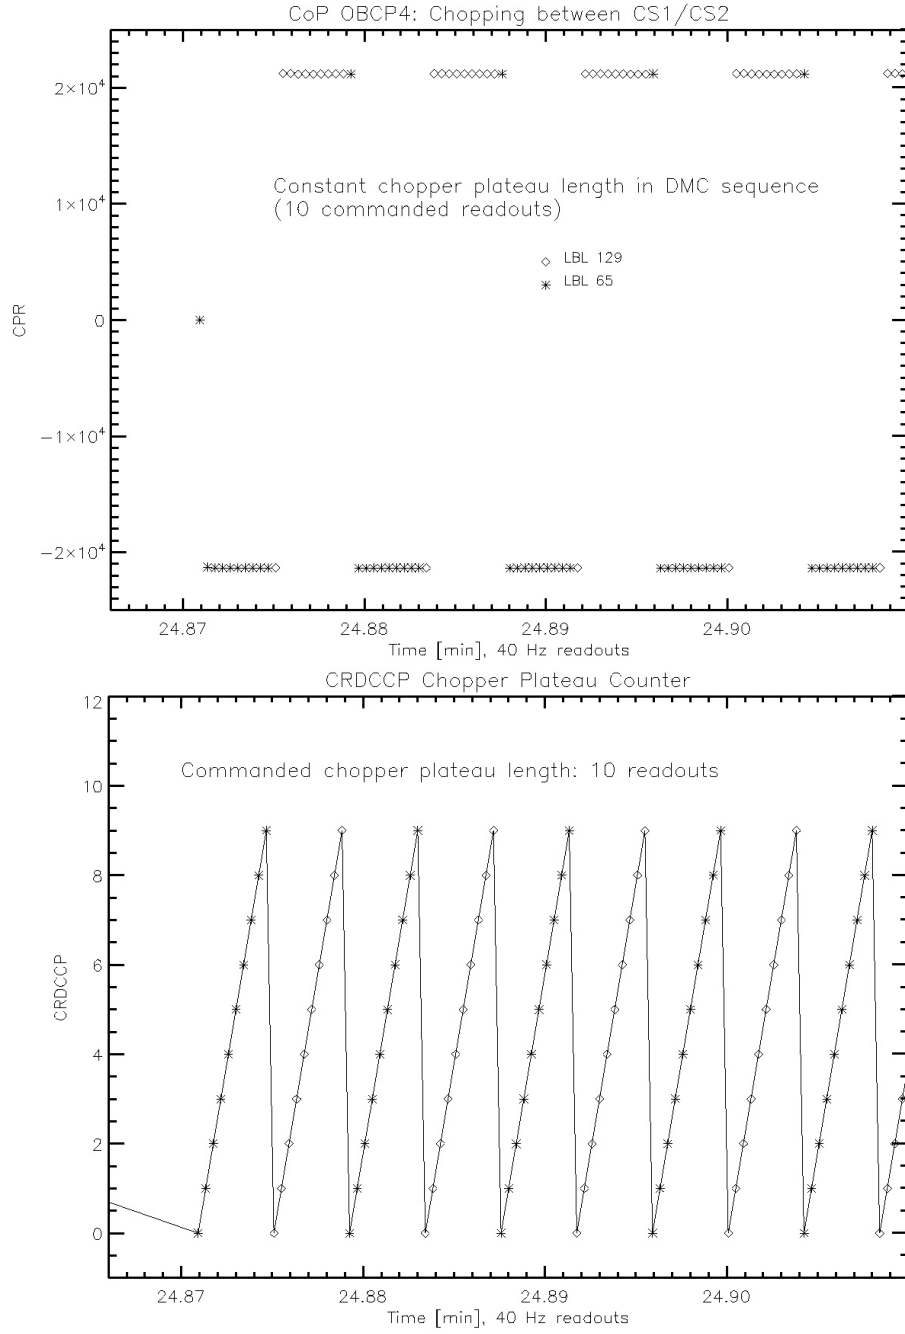
Figure 3: The CPR and CRDCCP for the 13th DMC sequences with 10 commanded readouts per chopper plateau. The chopper transition takes place exactly after the first readout with the new label. The CRDCCP increases by one for each readout on each chopper plateau from 0 to 9.

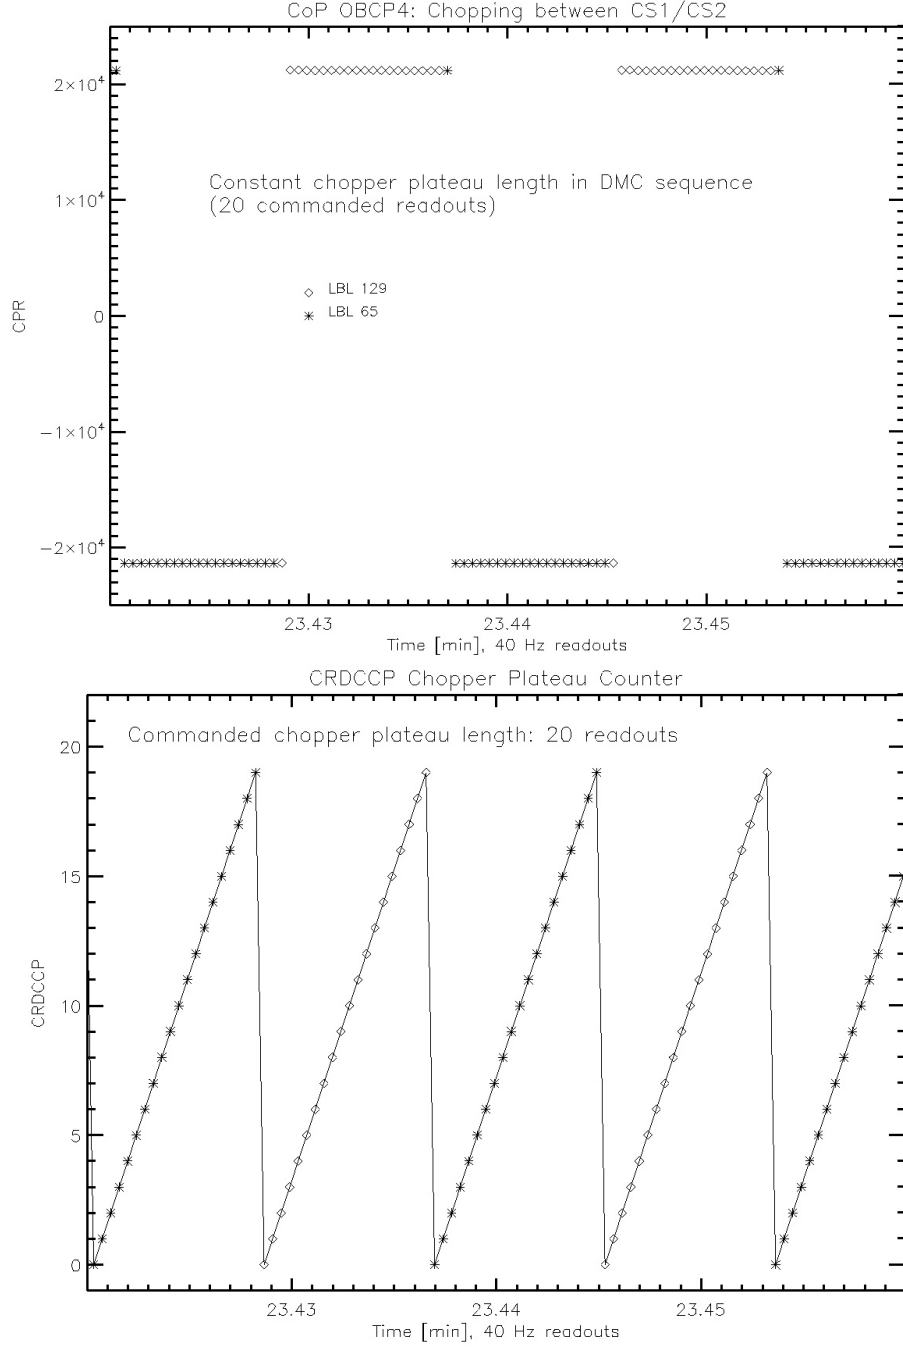
Figure 4: The CPR and CRDCCP for the 12th DMC sequences with 20 commanded readouts per chopper plateau. The chopper transition takes place exactly after the first readout with the new label. The CRDCCP increases by one for each readout on each chopper plateau from 0 to 19.

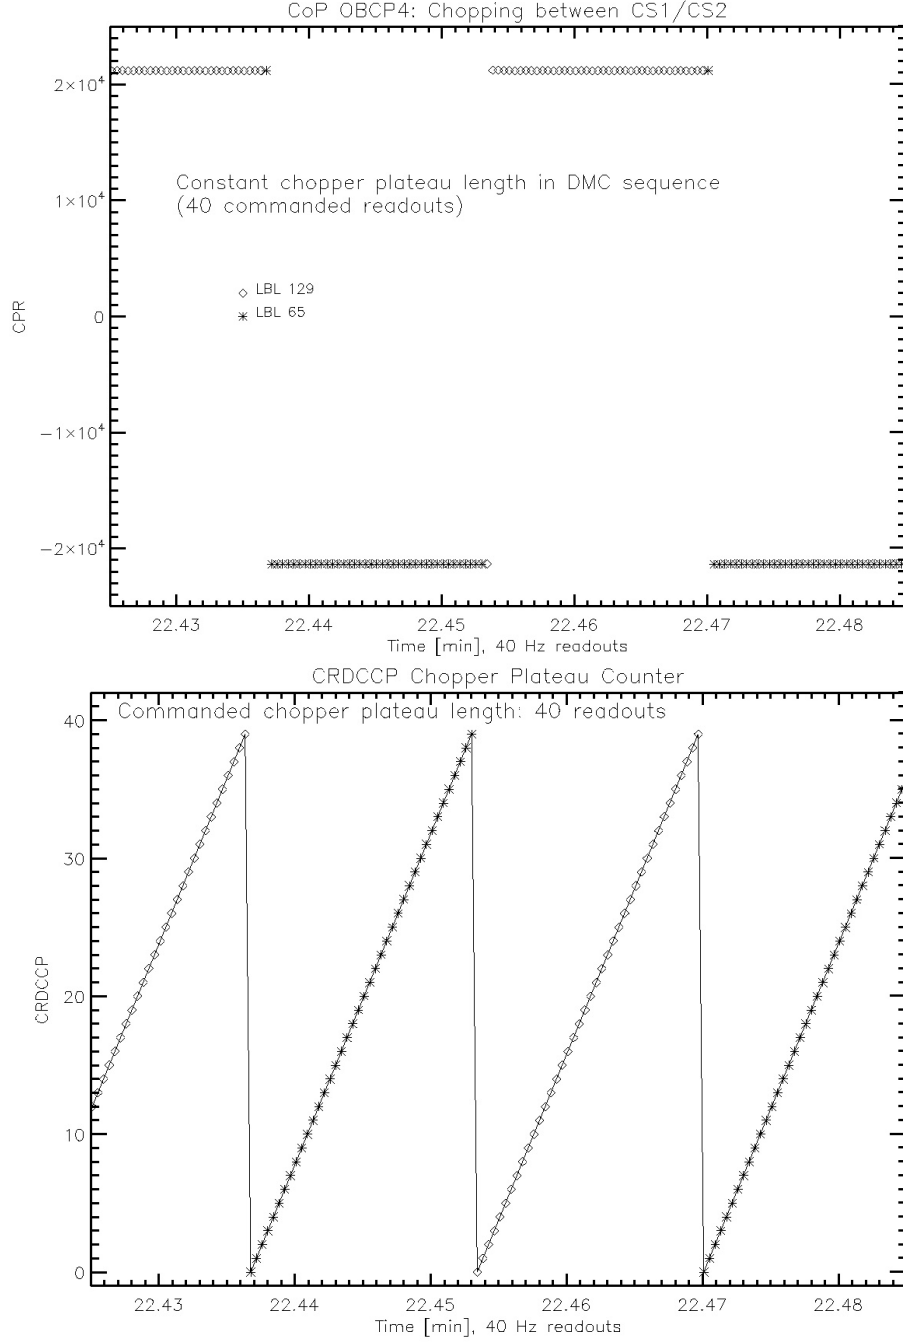
Figure 5: The CPR and CRDCCP for the 11th DMC sequences with 40 commanded readouts per chopper plateau. The chopper transition takes place exactly after the first readout with the new label. The CRDCCP increases by one for each readout on each chopper plateau from 0 to 39.

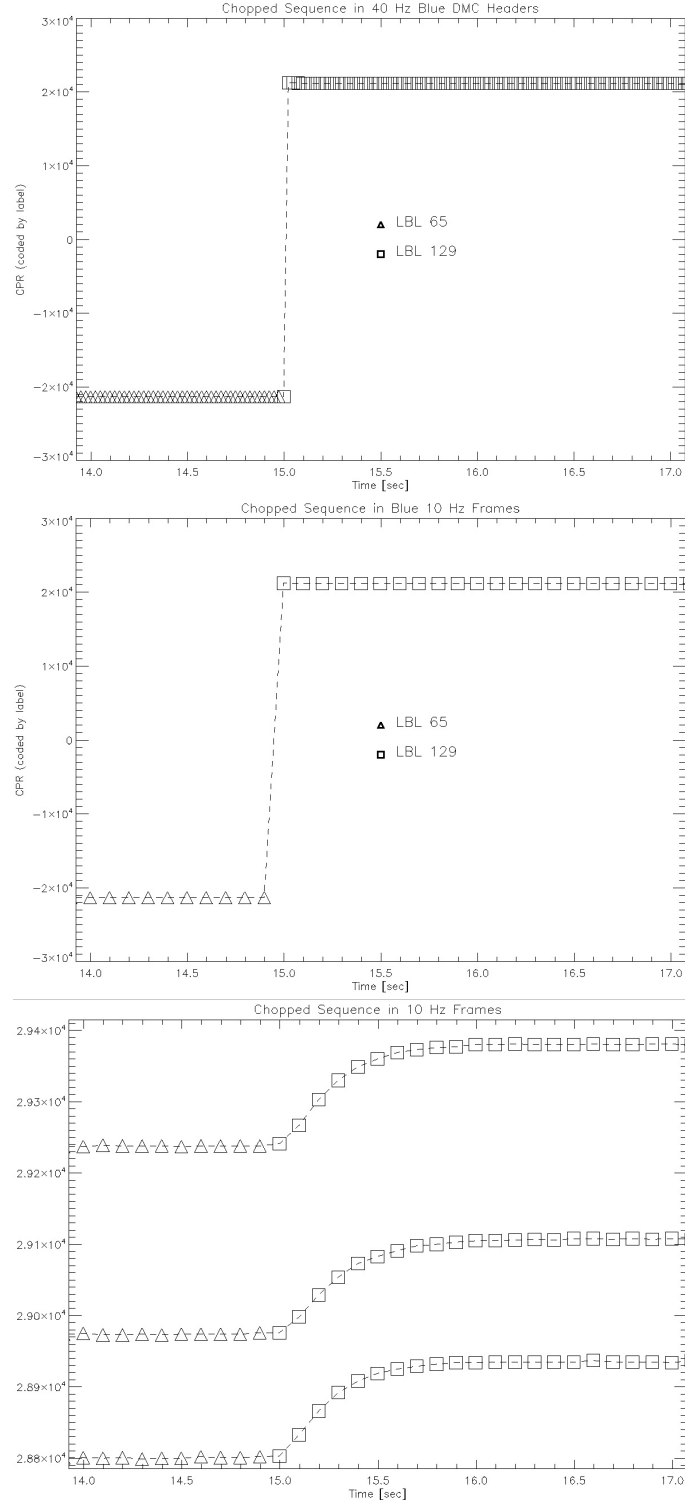
Figure 6: The CPR with 40 Hz time resolution as given in the DMC header entries (top), the CPR with 10 Hz as given on frames level (middle) and the signal (here only the VRL signal and **not** the bolometer signal) as given in the frames (bottom). The sequence shown is taken from the first OBCP execution. The CPR (top, middle) are plotted symbols coded by the corresponding label information. The chopper movement takes place right after the label change, but the SPU is correctly averaging the CPR information (and also the signal information) **after** the chopper transition has taken place. This is related to the shift of 1 readout when starting the quadruple averaging after a DMC sequence has started. The corresponding SPU parameter "SDEL" is therefore correctly implemented in "CONF_PHOT_params" in the variables syncdel_red and syncdel_blue (for all configurations set to 1) and correctly applied onboard. The signals shown here (bottom) are only VRL signals and are not representative in any kind.
