FMECA for use of newly proposed Dissipative mode DT - 05-11-09

Objectives

To identify potential risks and assess the impact of the proposed Dissipative mode as instrument state during standby (prime and non-prime) periods.

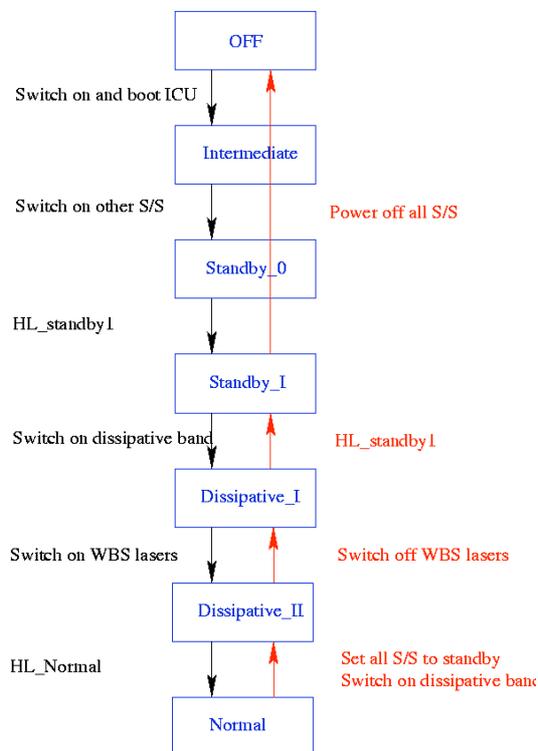
The new scheme can be sketched as follows:

The mode discussed here is the Dissipative one, which is entered in the respective *Standby_I* to *Dissipative_I* and *Normal* to *Dissipative_II* transitions. Note that the LCU state in *Dissipative_I* and *Dissipative_II* is unchanged.
